NASIRIYAH FIRE STATION
NASIRIYAH, IRAQ

SIGIR PA-06-053
JULY 24, 2006

SUBJECT: Report on Project Assessment of the Nasiriyah Fire Station, Nasiriyah, Iraq
(Report Number SIGIR-PA-06-053)

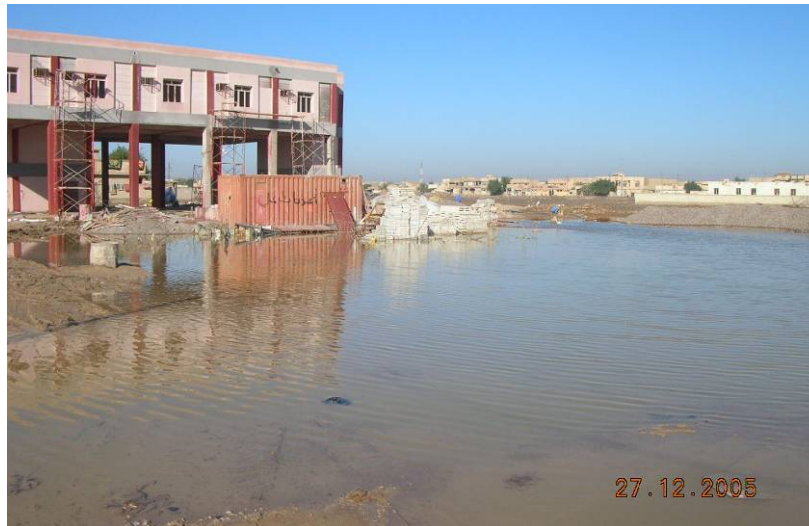
plain and the topography of the fire station site is level. The site does not drain very well since it is relatively flat. Site Photo 1 shows standing storm water runoff in front of the fire station site. The city street is located approximately 125 meters (m) away from the fire station.

**Site Photo 1. Standing water on the front side of the of the fire station –
Photo provided by USACE**

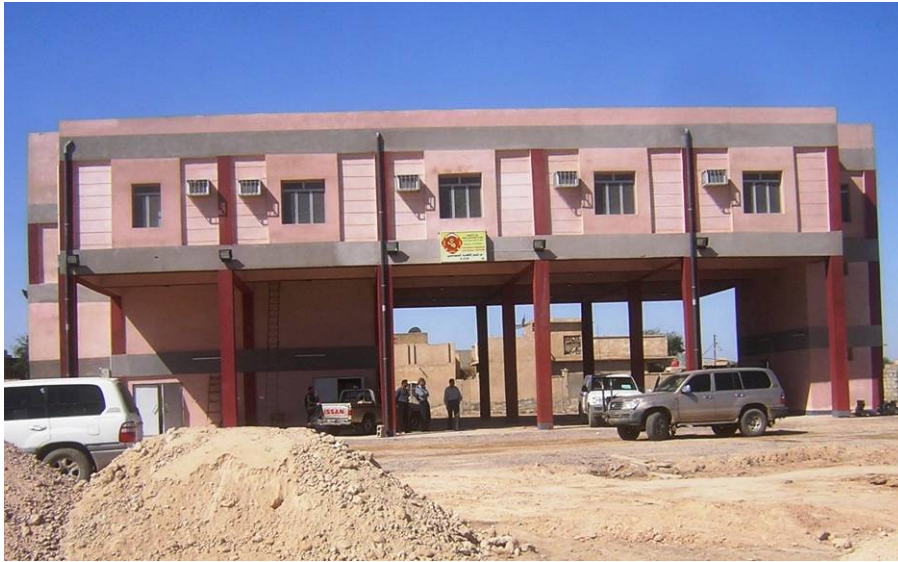
truck and SUV parking areas. However, based on the preferences expressed by the ICDD to remove the doors from the scope of work, the USACE opted for an “open” parking area as seen in Site Photo 2.

**Site Photo 2. Fire station one month before turnover to Iraq Civil Defense Directorate
Photo provided by USACE**

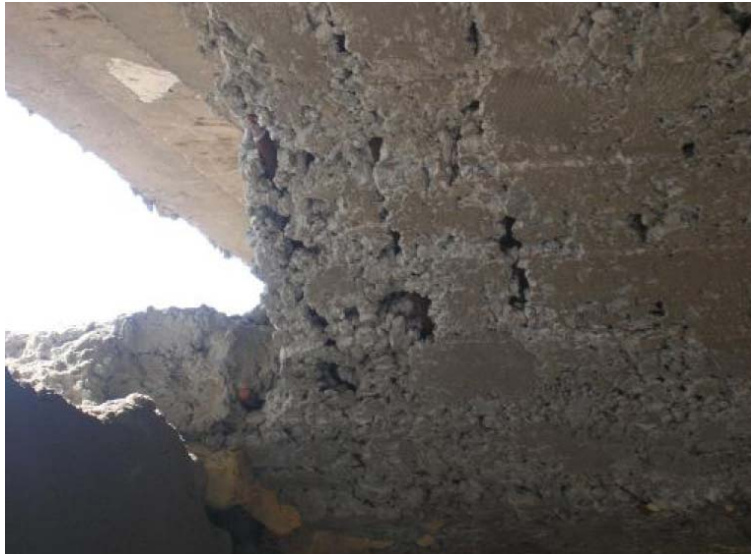
“The cast-in-place columns, beams and slabs where fresh concrete is exposed show indications of improper placement of reinforcing steel with insufficient overlap on the steel bars to provide load transfer; poor quality control on concrete mix preparation, placement, vibration, and curing; and generally poor construction practices that may result in loss of vertical and horizontal control.”

Site Photos 3, 4, and 5 provide examples of some of the concrete problems, such as segregation, poor quality workmanship, and insufficient length of overlapping reinforcement.

**Site Photo 3. Segregated concrete on stairs due to improper placement –
Photo provided by USACE**

The contractor met with USACE GRS personnel and submitted a plan for correcting the problems. The contractor's plan, approved by USACE on 24 September 2005, included the removal and replacement of deficient concrete stairs. In addition, the plan included the use of an epoxy patching material to repair the voids and areas of segregated concrete. Based on a review of the USACE Quality Assurance Representative's (QAR) deficiency log, the concrete deficiencies noted in the stop work order were corrected by January 2006.

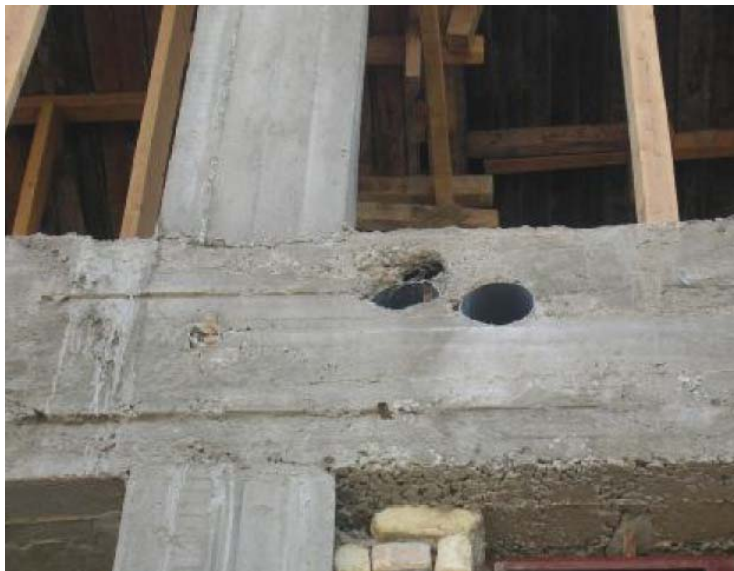
**Site Photo 4. Hole in concrete beam above pipe sleeve; also segregated concrete on bottom of
beam – Photo provided by USACE**

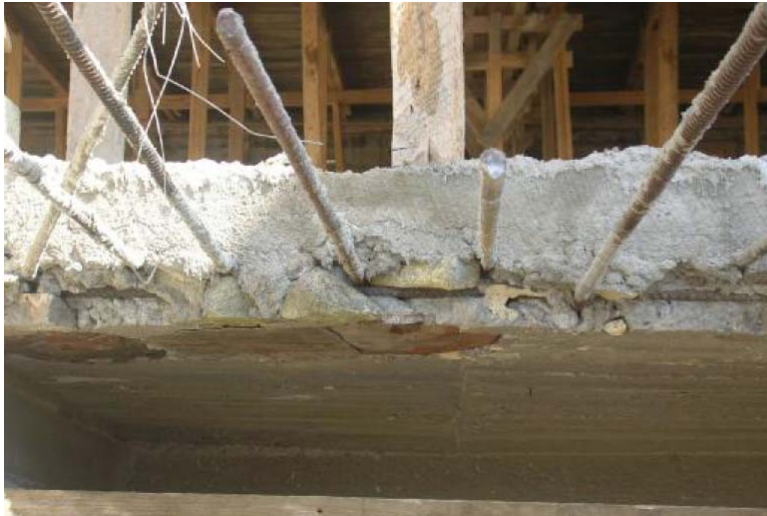
Site Photo 5. Improper placement of reinforcing steel with insufficient length along at a stair landing - Photo provided by USACE

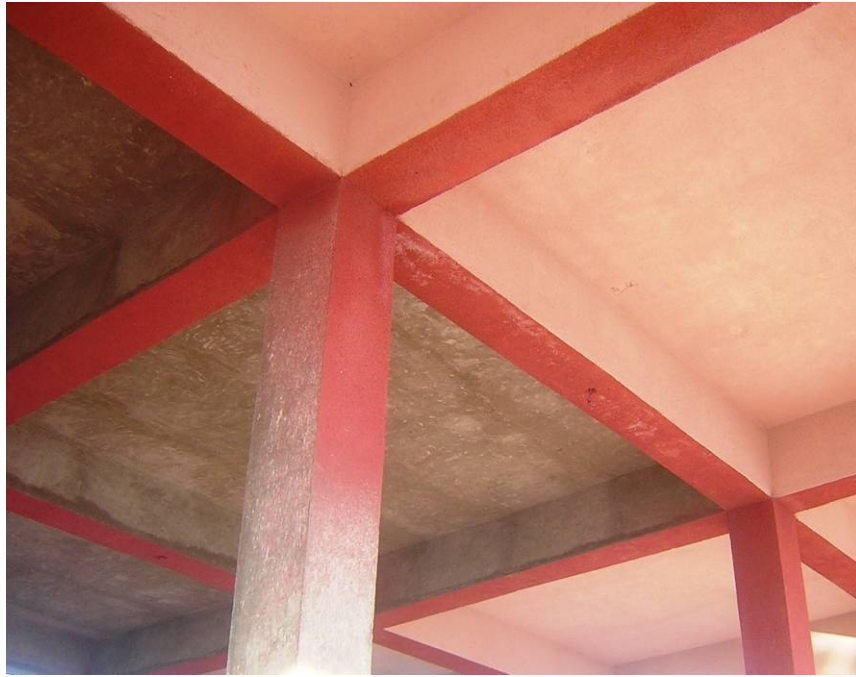
Site Photo 6 shows part of the structural frame supporting the third level after repairs to structural concrete had been completed and during the painting phases. The reinforced concrete beams' cross sectional dimensions are 400 mm by 650 mm. The reinforced concrete columns' cross sectional dimensions are 400 mm by 400 mm. If there were voids in the concrete, the contractor filled them using the epoxy patching material. After patching, the contractor applied a cement-sand plaster mix to the concrete surfaces prior to painting the surfaces.

Site Photo 6. Reinforced columns and beams supporting level 3 – Photo provided by USACE

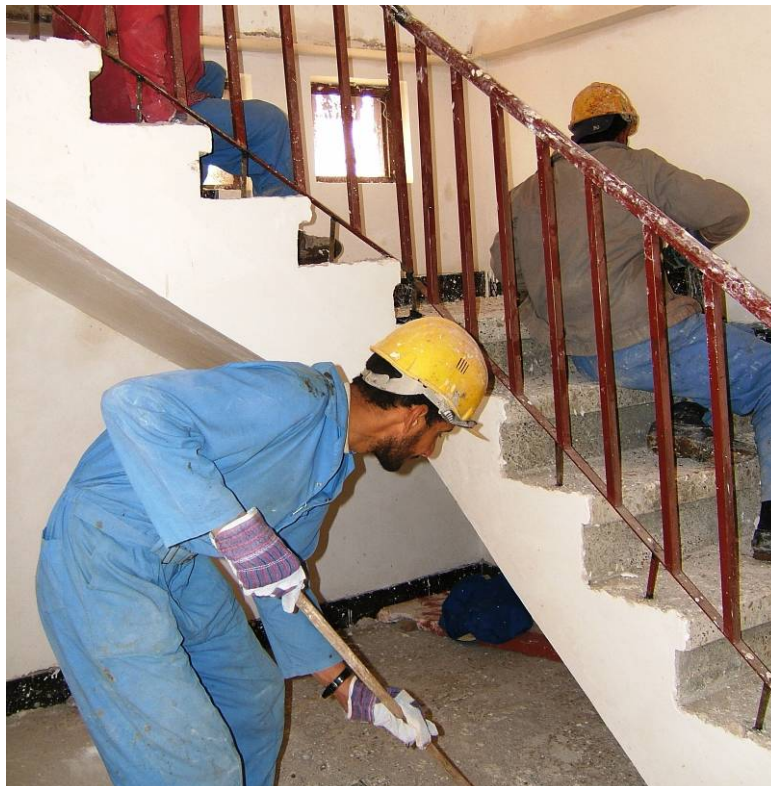
In addition, the contractor replaced reinforced concrete stairs as directed by USACE. After the new stairs were in place and properly cured, the contractor placed terrazzo tile on the stair risers and treads. The other exposed surfaces of the stairs were finished with cement-sand plaster. The design for the stairs required each step to have a 300 mm run and 170 mm rise. Site Photo 7 shows one section of a set of stairs, after the stairs were painted and tile was placed. The rise and run dimensions appear to meet the dimension requirements in the design.

Site Photo 7. Concrete stairs at ground level – Photo provided by USACE

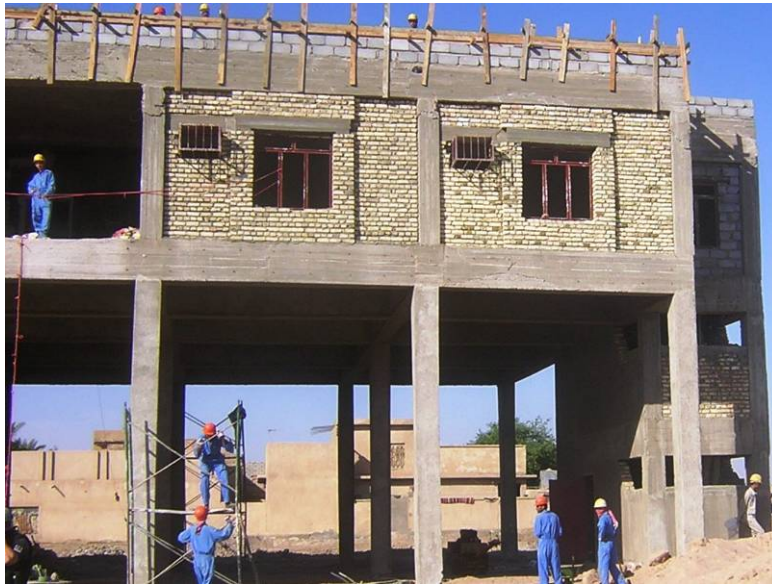
construction progress photos, the contractor utilized bricks (Site Photo 8) and block (Site Photo 9) to construct masonry walls. The drawings did not specify the type of bricks required for the construction of the block walls.

Site Photo 8. Exterior brick walls on third level – Photo provided by USACE

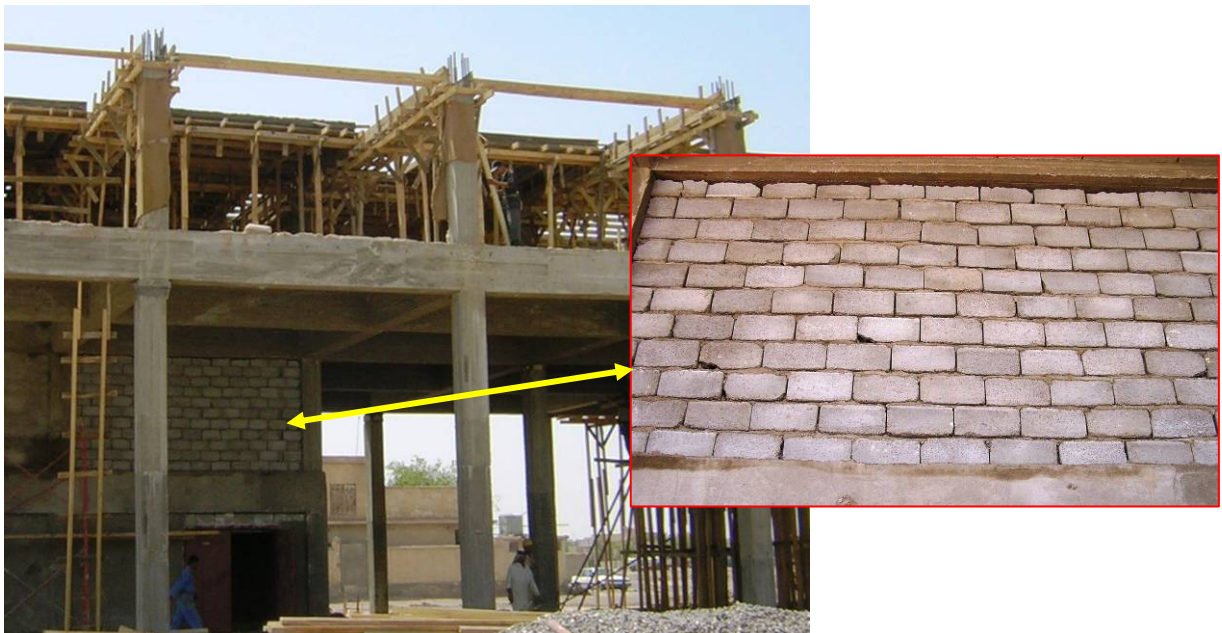
Site Photo 9. Block wall on mezzanine level – Photo provided by USACE

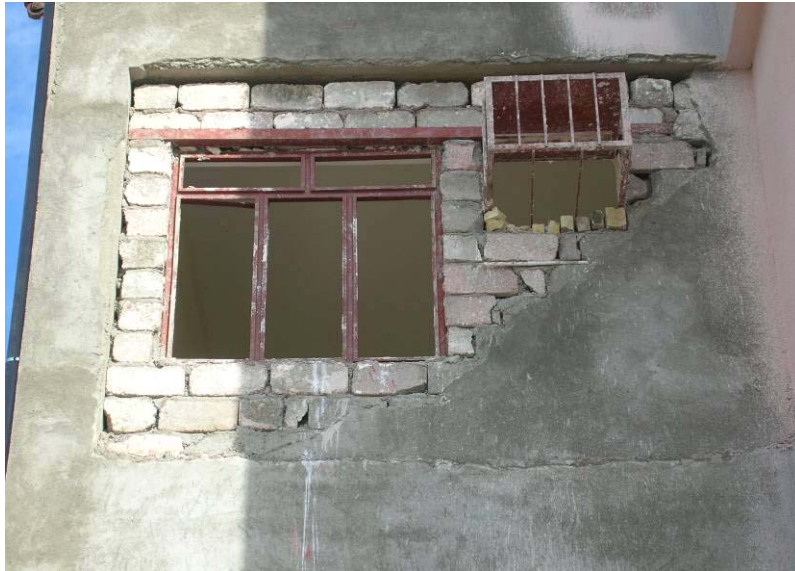
During the course of construction, the USACE QAR did identify poor workmanship in constructing one of the exterior walls. According to the Quality Assurance (QA) Deficiency Log, the wall shown in Site Photo 10 was identified as a problem in December 2005. Two weeks later, the deficiency had been corrected and the wall replaced.

Site Photo 10. Poorly constructed wall reconstructed after direction from USACE – Photo provided by USACE

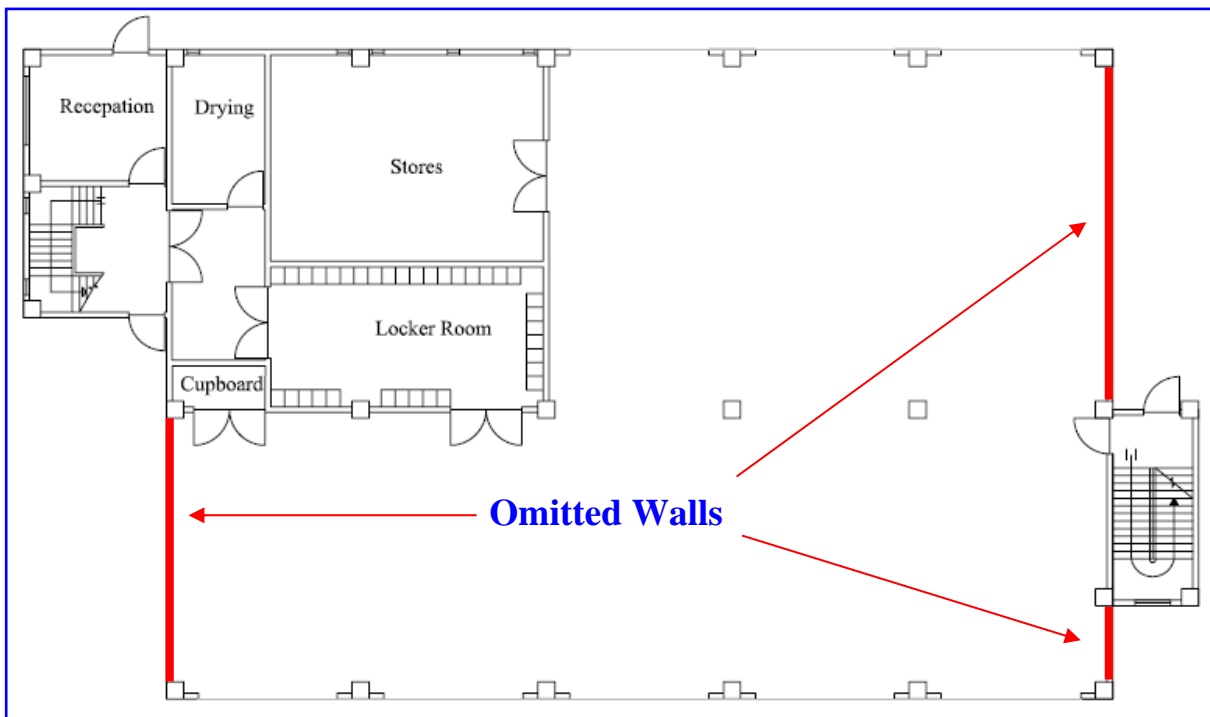
Also, the contractor failed to construct exterior walls at ground level on each side of the fire station. The USACE QAR discussed the missing non-load bearing walls with representatives of the ICDD, and the ICDD reported that the walls were not necessary. Since the walls were not load bearing, the walls were omitted from the contract requirements. The omitted walls on each side of the building are shown in Diagram 1.

Diagram 1. Ground floor plan showing location of exterior walls not constructed

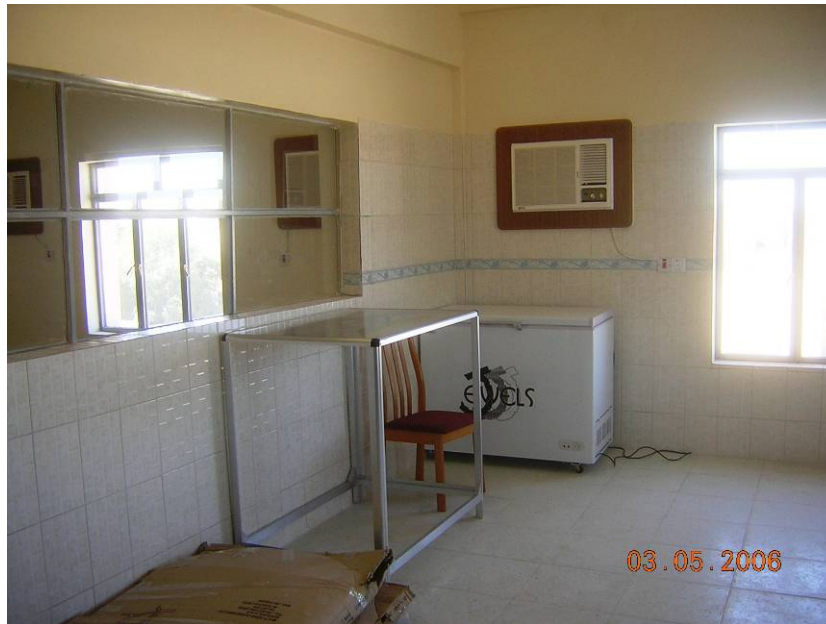
For finishing the exterior and interior walls and ceilings, the bill of quantities listed plastering and painting. The bill of quantities required the plastering of exterior walls with a sand cement mortar and the interior walls and ceilings with a gypsum plaster. For flooring, the contractor installed terrazzo floor tile in all areas except for the kitchen and bathroom areas, where ceramic tile was utilized. In addition, ceramic tile was used on the showers and water closet walls, as well as on the other wall surfaces in the bathrooms. In the kitchen, as shown in Site Photo 11, the contractor placed ceramic tile on the walls to a height equal to the top of the window.

Site Photo 11. Kitchen with ceramic tile wall covering

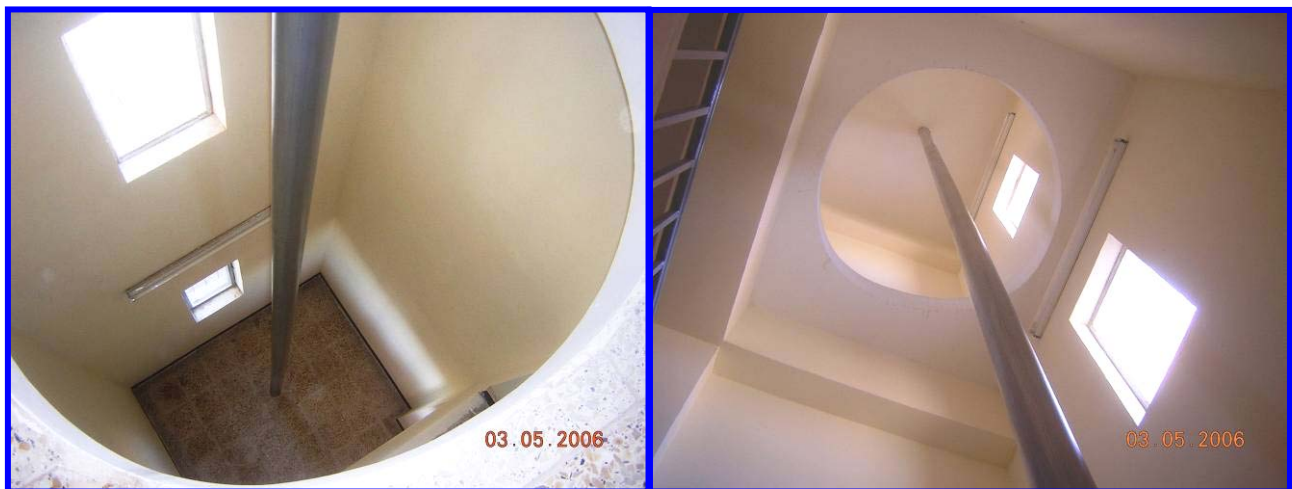
Another architectural feature in the building inherent with fire stations is the fireman's pole. The contractor's design showed a four inch diameter steel pole to provide direct access to the ground floor level from the living areas on the third level. Site Photo 12 shows two perspectives of the completed fireman's pole and the opening through the floor slab.

Site Photo 12. Top and bottom perspective of the fireman's pole

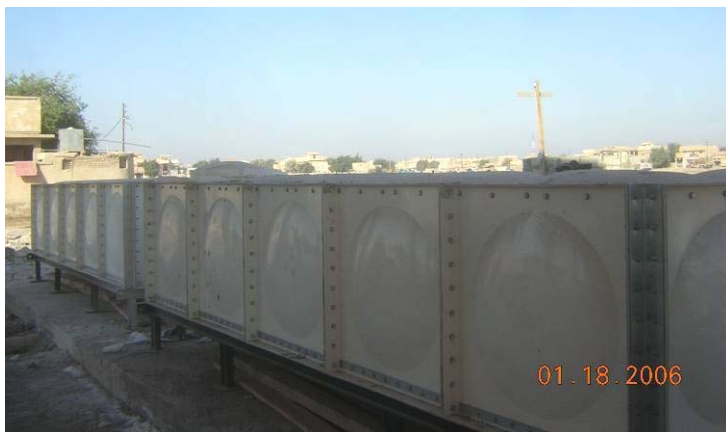
The contract design required two water storage tanks, each with a capacity of 10 cubic meters (m^3) to be constructed at the ground level on one side of the station. In addition, the design included eight, one m^3 roof top water tanks. Through a review of the construction progress photos, we verified the installation of the two ground level tanks, and five roof top tanks, although we could not determine their capacity. Site Photos 13 and 14 show the two types of water tanks installed at the fire station.

**Site Photo 13. Surface level 10 m^3 water tanks –
Photo provided by USACE**

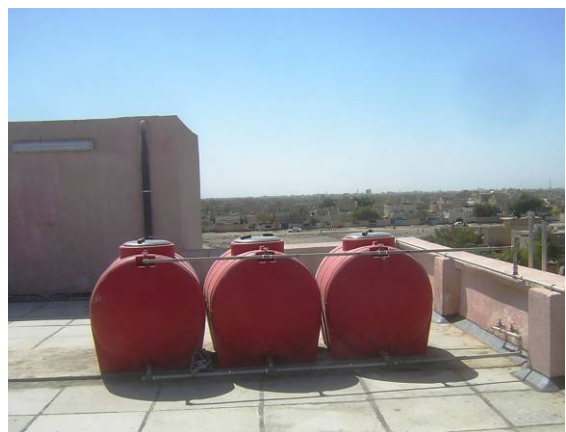
**Site Photo 14. Roof top water tanks –
Photo provided by USACE**

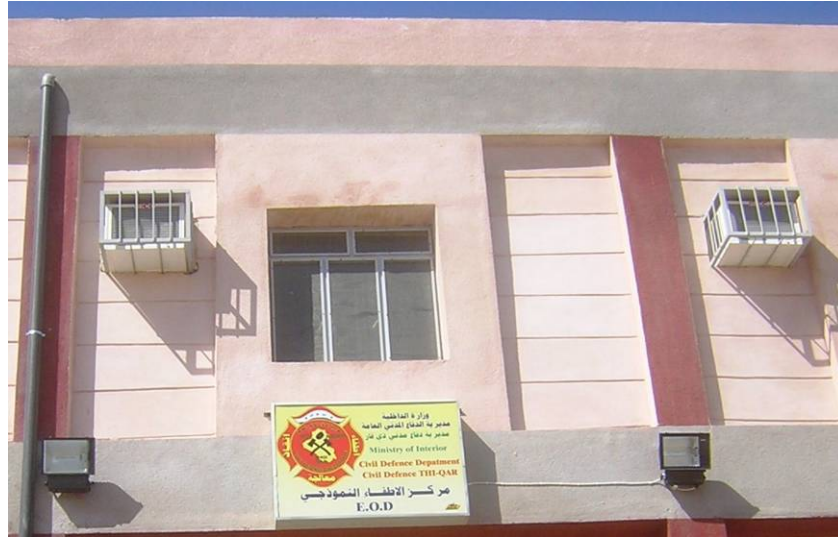
The design required two sizes (1.5 and 2 ton) of window type heating, ventilation and air conditioning (HVAC) units for the fire station. There were no details in the design drawings showing the wall opening or installation requirements. However, review of the QA information indicated no discrepancies in their installation. Site Photo 15 shows two window HVAC units installed in the fire house.

**Site Photo 15. Window type HVAC units on third level of the fire station –
Photo provided by USACE**

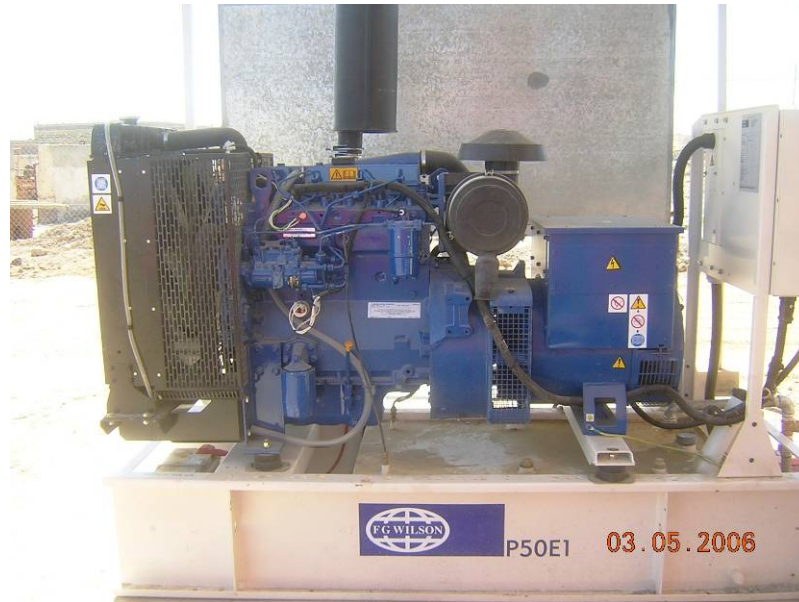
The design drawings required a 50 kilovolt amp generator to be located adjacent to the building on a concrete pad. Site Photo 16 shows an “F. G. Wilson” generator, model P50E1 installed at the fire station. The assessment team reviewed the catalog cut information provided by the USACE PE, and verified the generator met the contract requirements.

Site Photo 16. Generator installed at the fire station – Photo provided by USACE

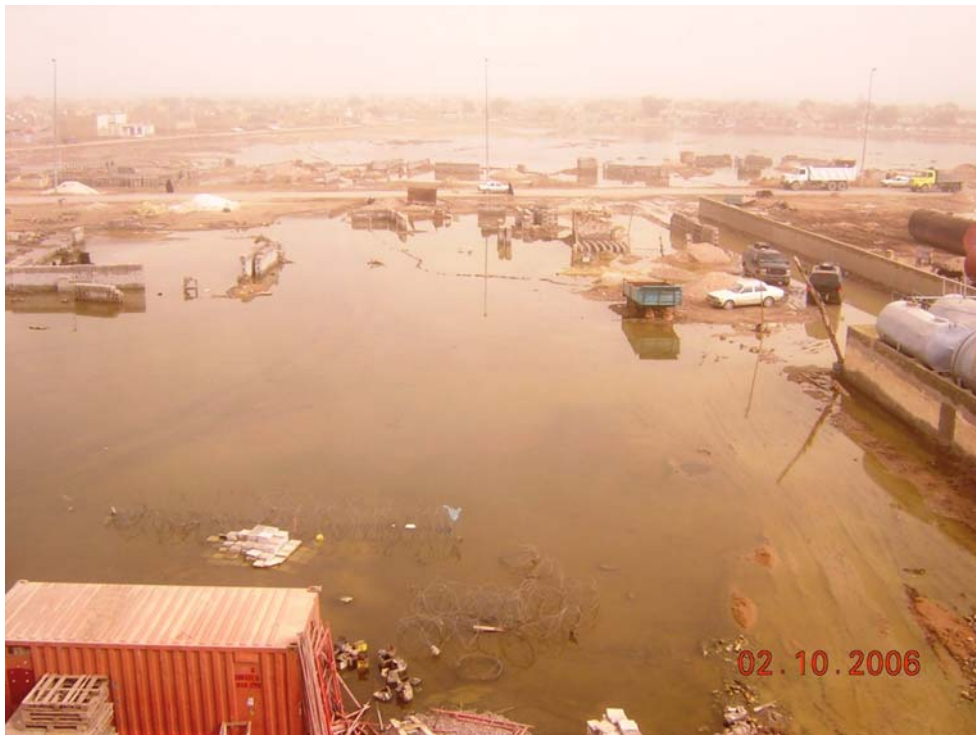
Another issue that could impact sustainability is the poor drainage around the fire station. The Nasiriyah Fire Station site is level. The site does not drain well since it is relatively flat, and the city street is located approximately 125 meters (m) away from the fire station. Site Photo 17 shows standing storm water runoff in front of the fire station site. During an interview, the USACE stated that the contractor provided the fire station with an entryway that has sub-base materials, but the project did not address drainage.

Site Photo 17. Standing water – Photo provided by USACE
